PACSystems RX3i

IC695CPE310-ABAL

Central Processing Unit

GFK-2713L

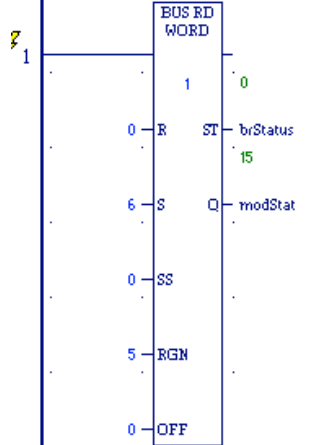
New Feature	Description																																
<p>Support for IC695RMX228</p>	<p>Supports the 128 MB Reflective Memory Module with Single Mode Transceiver.</p>																																
<p>Ability to read the reflective memory status bits for IC695CMX128, IC695RMX128, and IC695RMX228 (all reflective memory modules)</p>	<p>Status bits for the reflective memory modules have been added and can be read using the BUS_READ_WORD function. If the function is successful, each bit returned will reflect the current state of the corresponding bit on the module faceplate, with a value of 0 being the equivalent of the LED being OFF, and a value of 1 being the equivalent of the LED being ON. This request will only work for reflective memory modules that are present and configured.</p> <p>Use of the BUS_READ_WORD function block:</p> <pre> LENGTH: 1 INPUTS: Rack = 0 Slot = <actualSlot> Subslot = 0 Region = 5 Offset = 0 OUTPUTS: Status = BUS_RD_WORD execution status Q = Module status </pre>

<p>If the ST output is 0, the data returned on the Q output of the BUS_READ_WORD block has the following format:</p> <table border="1" data-bbox="537 972 1453 1073"> <tr> <td>Bit 07</td> <td>Bit 06</td> <td>Bit 05</td> <td>Bit 04</td> <td>Bit 03</td> <td>Bit 02</td> <td>Bit 01</td> <td>Bit 00</td> </tr> <tr> <td colspan="4">Reserved</td> <td>OWN DATA</td> <td>SIG DETECT</td> <td>LINK OK / CONFIG</td> <td>OK</td> </tr> </table> <table border="1" data-bbox="537 1108 1453 1182"> <tr> <td>Bit 15</td> <td>Bit 14</td> <td>Bit 13</td> <td>Bit 12</td> <td>Bit 11</td> <td>Bit 10</td> <td>Bit 09</td> <td>Bit 08</td> </tr> <tr> <td colspan="8">Reserved</td> </tr> </table>	Bit 07	Bit 06	Bit 05	Bit 04	Bit 03	Bit 02	Bit 01	Bit 00	Reserved				OWN DATA	SIG DETECT	LINK OK / CONFIG	OK	Bit 15	Bit 14	Bit 13	Bit 12	Bit 11	Bit 10	Bit 09	Bit 08	Reserved
